CHALK MINE STABILISATION PROJECT HIGHBARNNS, HEMEL HEMPSTEAD

Treatment Area 2: Nos. 10 and 12 Pond Road

Report Number: 0013-UA000857-TR-01-TAR-0002

OCTOBER 2015

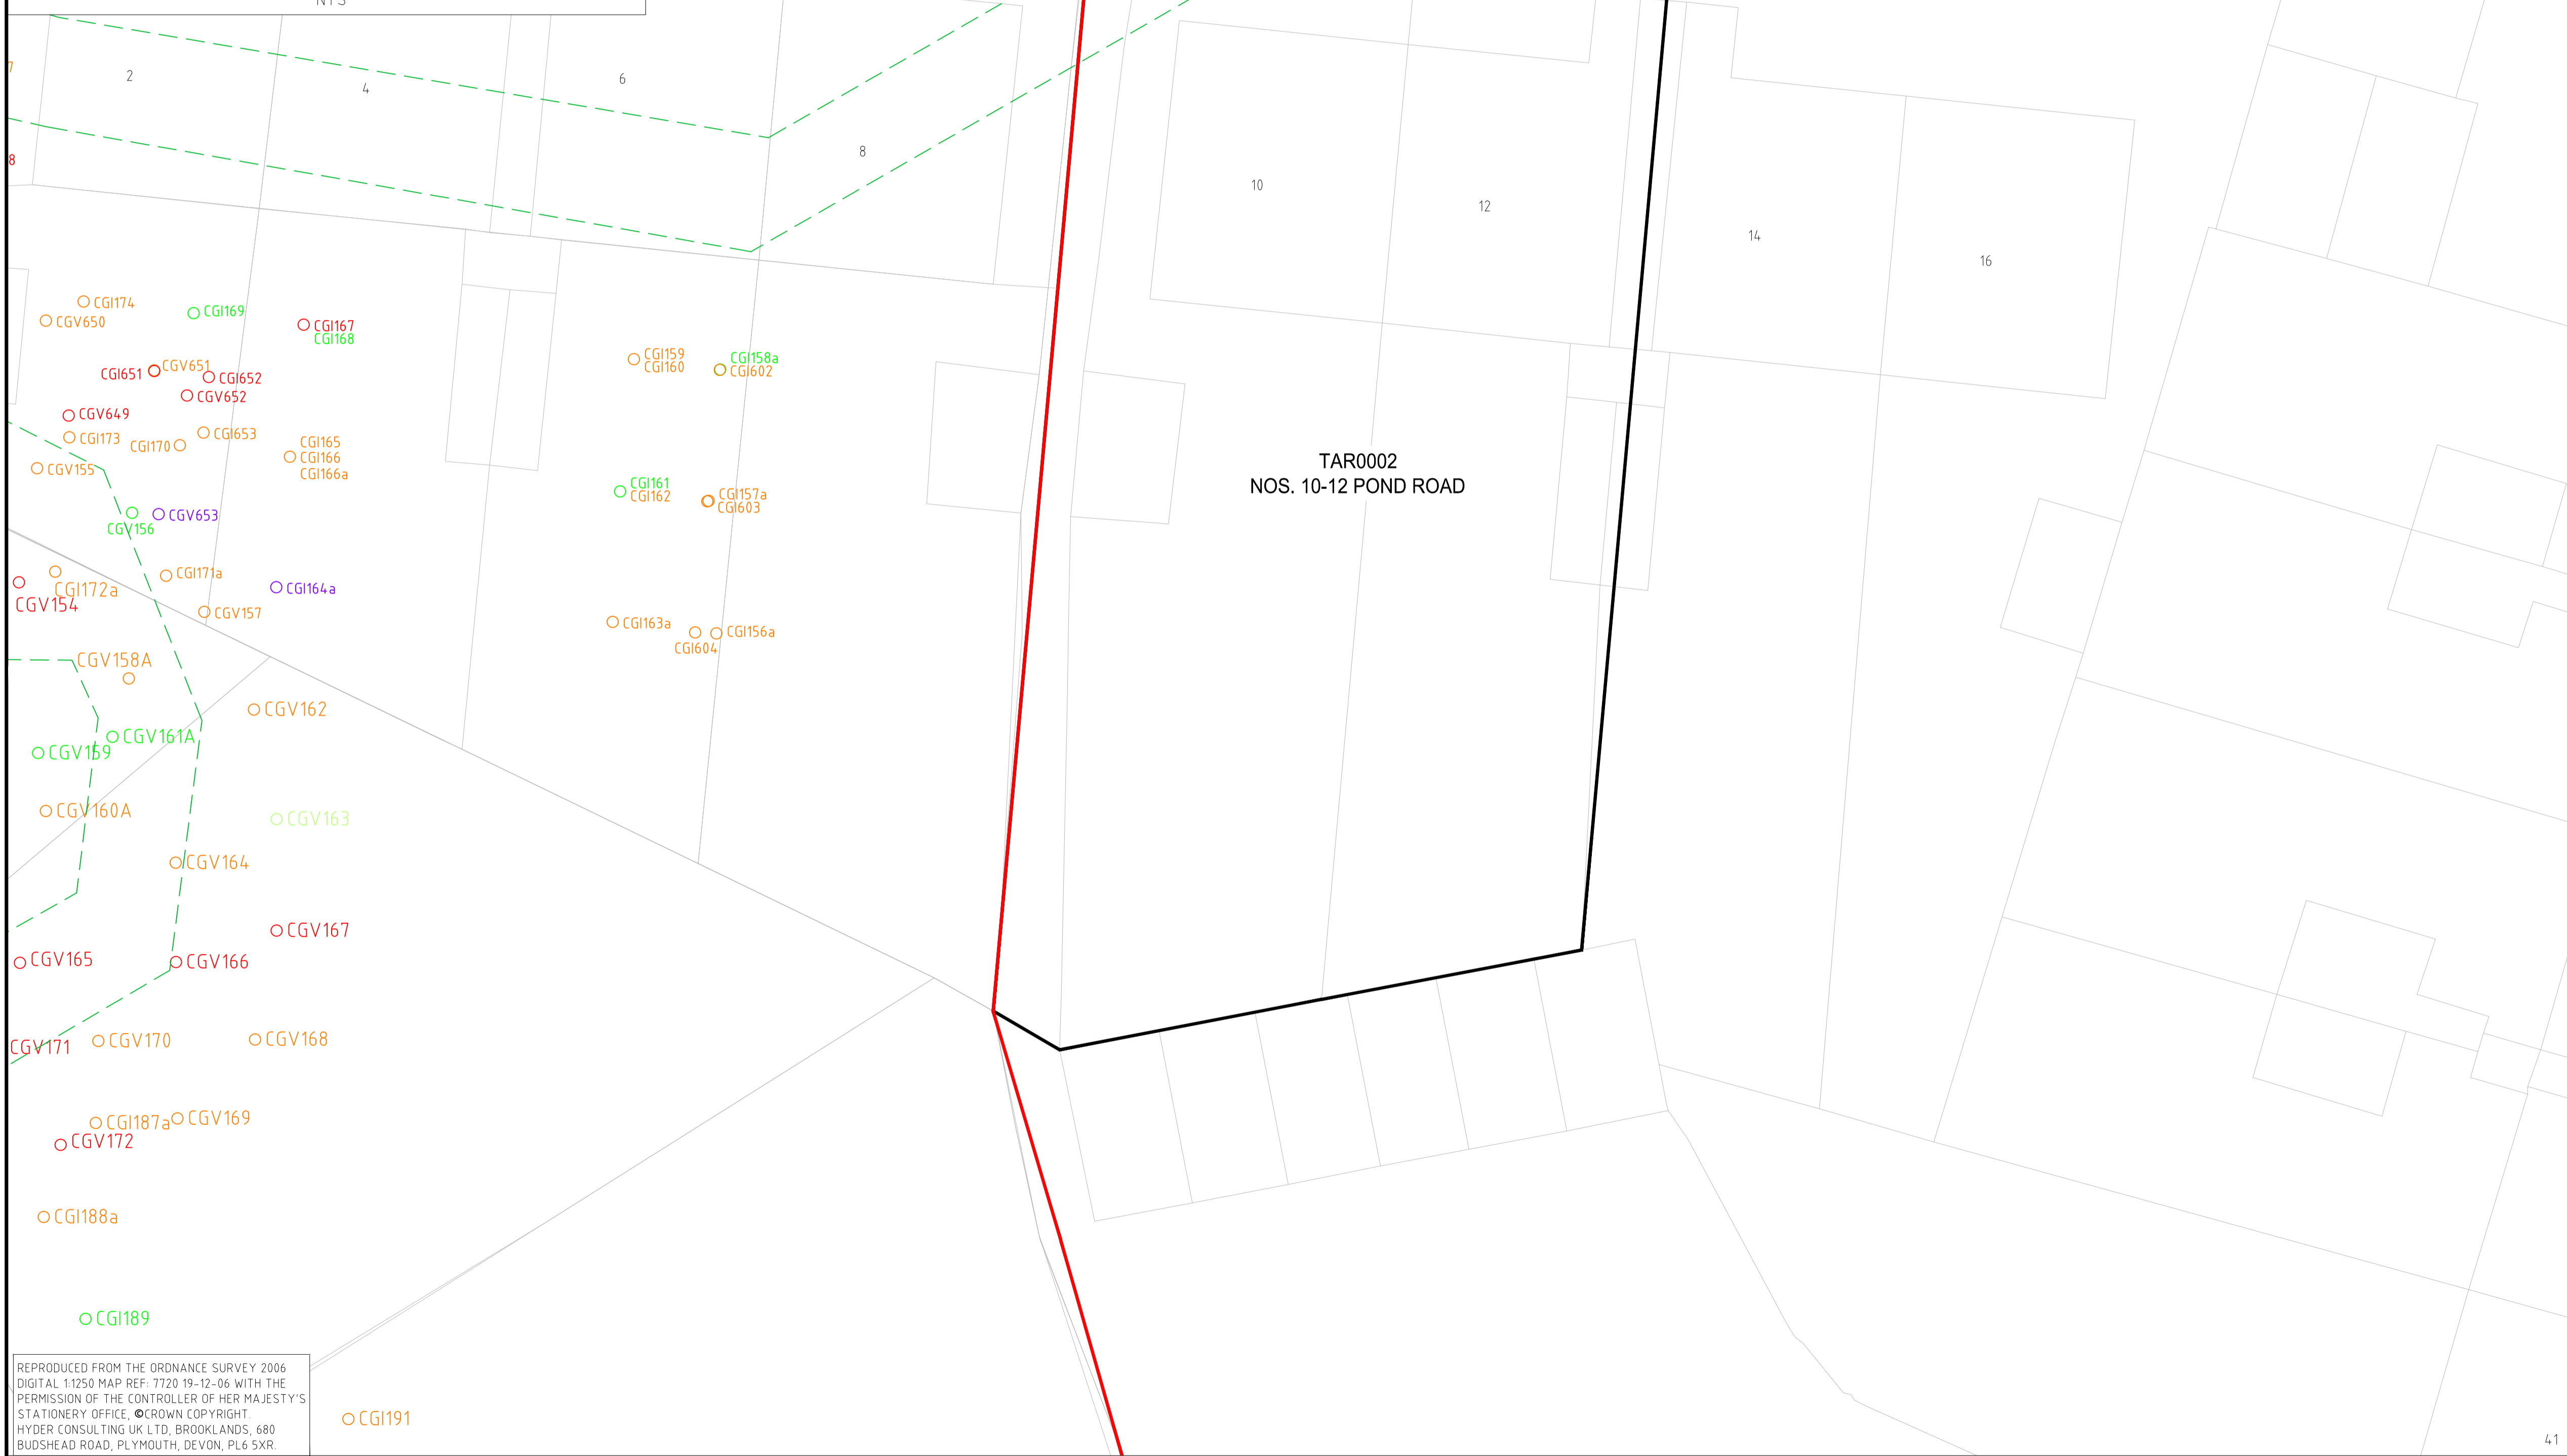
**Drawing TA02-01 – Treatment Area Plan for TAR0002
with Grout Holes**

Grouting of No. 10 Pond Road was designed to treat the possible mine passage trending northeast-southwest beneath the front gardens that appears to be an extension of the mine passage beneath No. 8 Pond Road.

Validation probing located in No. 8 Pond Road identified weakness in the ground which prompted further work to investigate the extent of suspected mining disturbed ground beneath No. 10 Pond Road. A row of validation probes (VP496, VP497 & VP498) were initially undertaken during September 2013 in the passageway between No. 8 & No. 10 Pond Road. Low blow counts indicative of collapsed mine workings were recorded between depths of 12.9m and 13.4m bgl in VP497. Grouting works were therefore carried out in the passageway to treat the weak ground identified in VP497. This comprised a grout volume of 7.534m³ in grout hole CGV618 which indicated treatment of mining collapsed ground rather than an open void.

Further validation probing was undertaken in the front garden of No. 10 Pond Road to confirm the possible mine passage suspected to trend towards the northeast and across Pond Road. Validation probe blow counts indicative of mined ground were recorded in VP854 between depths of 17.6m and 18.6m bgl and in VP914 between depths of 14.0m and 17.0m bgl. Grout hole CGV24A was undertaken to treat the weak ground identified and a total grout volume of only 4.48m³ was injected.

An initial row of 2 No. validation probes were undertaken during April 2014 in the front garden of No. 12. Low blow counts were recorded between depths of 13.0m and 14.0m bgl in VP930 and between 12.0m and 12.9m bgl in VP931, indicative of mining disturbed ground. Grout hole CGV28A was undertaken to treat the front garden of No. 12 Pond Road and a grout volume of only 2.384m³ was injected. Validation probing undertaken subsequent to the treatment works and between the mine passage and the house (VPP19 & VP932) proved competent ground to 20.0m bgl. Two validation probes (VPP1 & VPP2) undertaken within the eastern side of the front garden No. 12 Pond Road proved competent ground to 20.0m bgl.

A second row of validation probes (VP920, VP921, VP922 & VP923) were undertaken towards the northern edge of Pond Road to investigate the presence of the suspected northeast trending mine passage. Low blow counts were recorded between depths of 15.3m and 17.1m bgl in VP922. Grouting works were therefore undertaken at CGV34 and CGV35 and grout volumes of 3.97m³ and 1.903m³ respectively were recorded

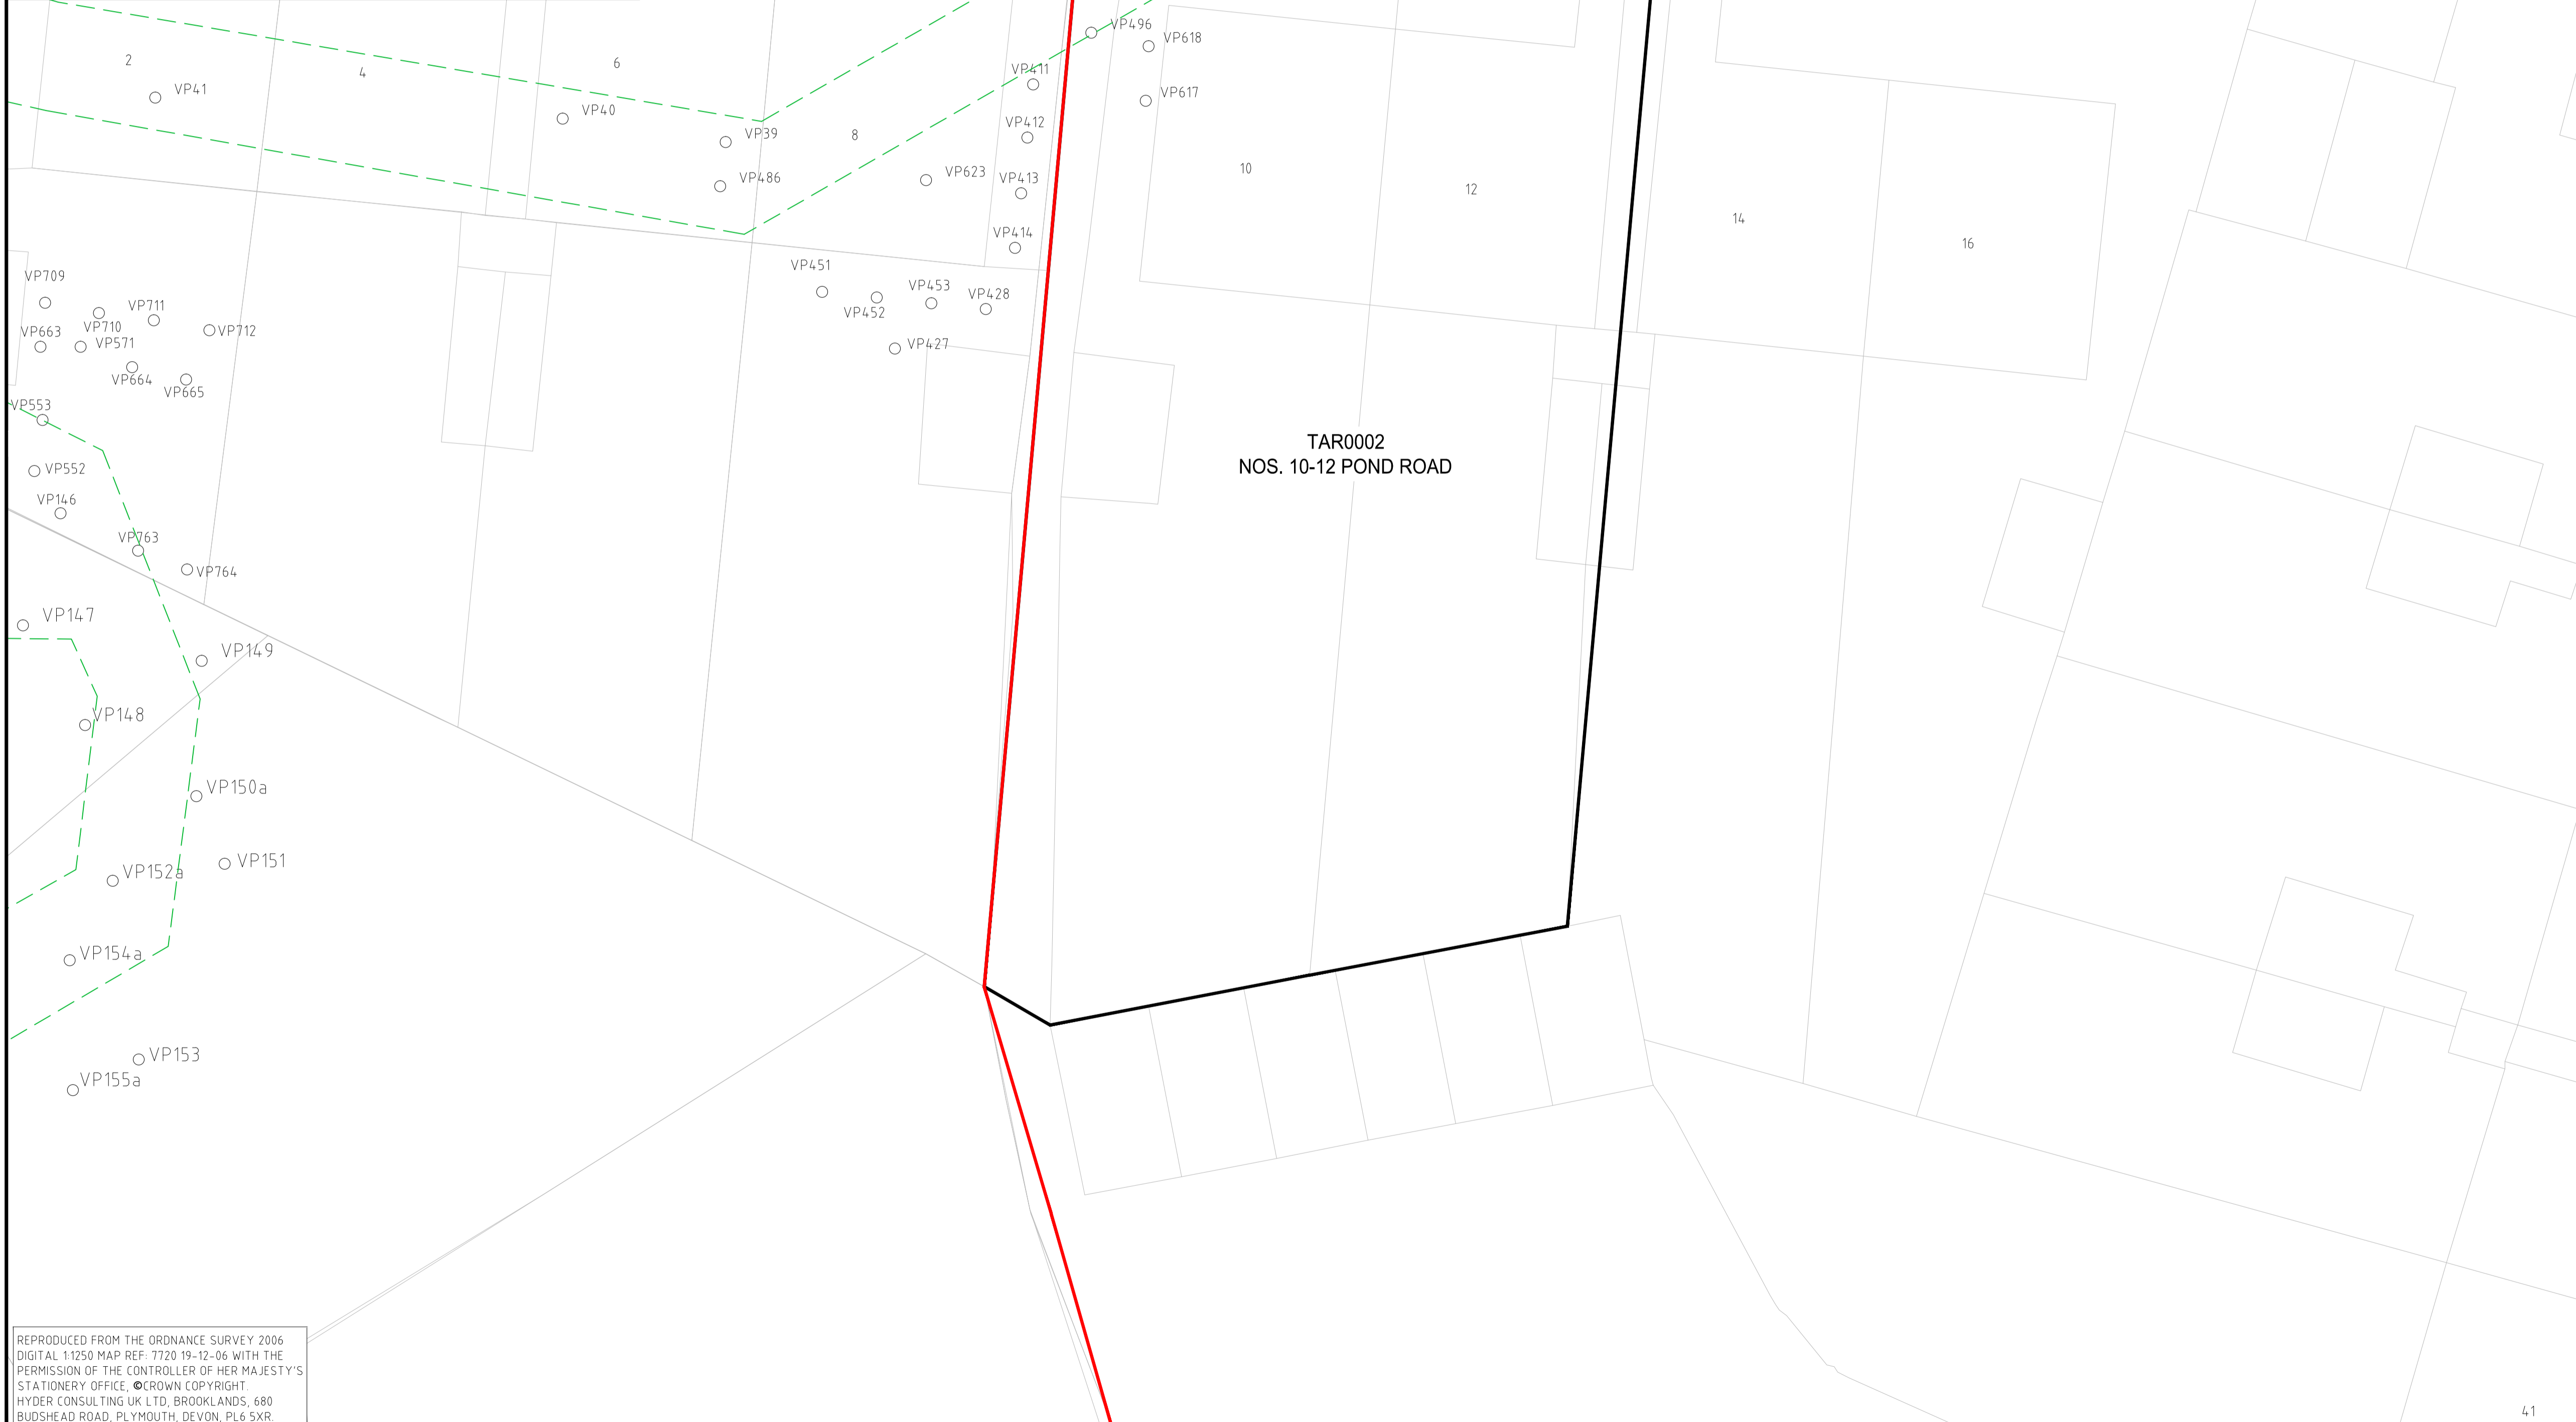
**Drawing TA02-02 – Treatment Area Plan for TAR0002
with Validation Probes**

Grouting of No. 12 Pond Road was designed to treat the possible second mine passage trending northeast-southwest leading off the passageway identified in front of No. 10 Pond Road. This is considered to be an extension of the mine passage from beneath No. 10 Pond Road which prompted validation probing and subsequent treatment at No. 12 Pond Road. An interpretation of the expected mine layout for No. 12 Pond Road is shown on Drawing TA0002-02 presented in Appendix A.

Grout along Pond Road was designed to treat the possible mine passage trending northeast-southwest extending from No. 12 Pond Road suspected to be present following validation probing and treatment at No. 10 and No. 12 Pond Road. An interpretation of the expected mine layout for Pond Road is shown on Drawing TA0002-02 presented in Appendix A.

An additional row of validation probes (VPP5, VPP8, VPP9 & VPP10) within Pond Road were undertaken in July 2014 to investigate the possible presence of mining disturbed ground extending from known passages identified in No. 10 & No. 12 Pond Road. Results did not indicate the presence of a mine passage, however a single validation probe (VPP13) undertaken in the middle of Pond Road recorded low blow counts between 12.5m and 13.5m bgl. Grout hole CGV31 was subsequently undertaken to treat this ground with a grout volume of 6.164m³ indicating the treatment of mining collapsed ground rather than an open void.

Further validation probing (VPP14, VPP15, VPP16, VPP31, VPP34, VPP35 & VPP36) was undertaken beyond this treatment towards the northern side of Pond Road in a north-easterly direction. Validation probing was undertaken to depths of between 18.5m and 22.9m. Results were marginally indicative of weak ground, therefore four grout holes (CGV31A, CGV33, CGV36 & CGV37) were undertaken to treat possible weak ground. Grout volumes ranged between 1.975m³ and 6.598m³ indicating the treatment of weak or collapsed ground rather than an open void.
