CHALK MINE STABILISATION PROJECT HIGHBARNNS, HEMEL HEMPSTEAD

Treatment Area 1: Nos. 2, 4, 6 and 8 Pond Road

Report Number: 0013-UA000857-TR-01-TAR-0001

OCTOBER 2015

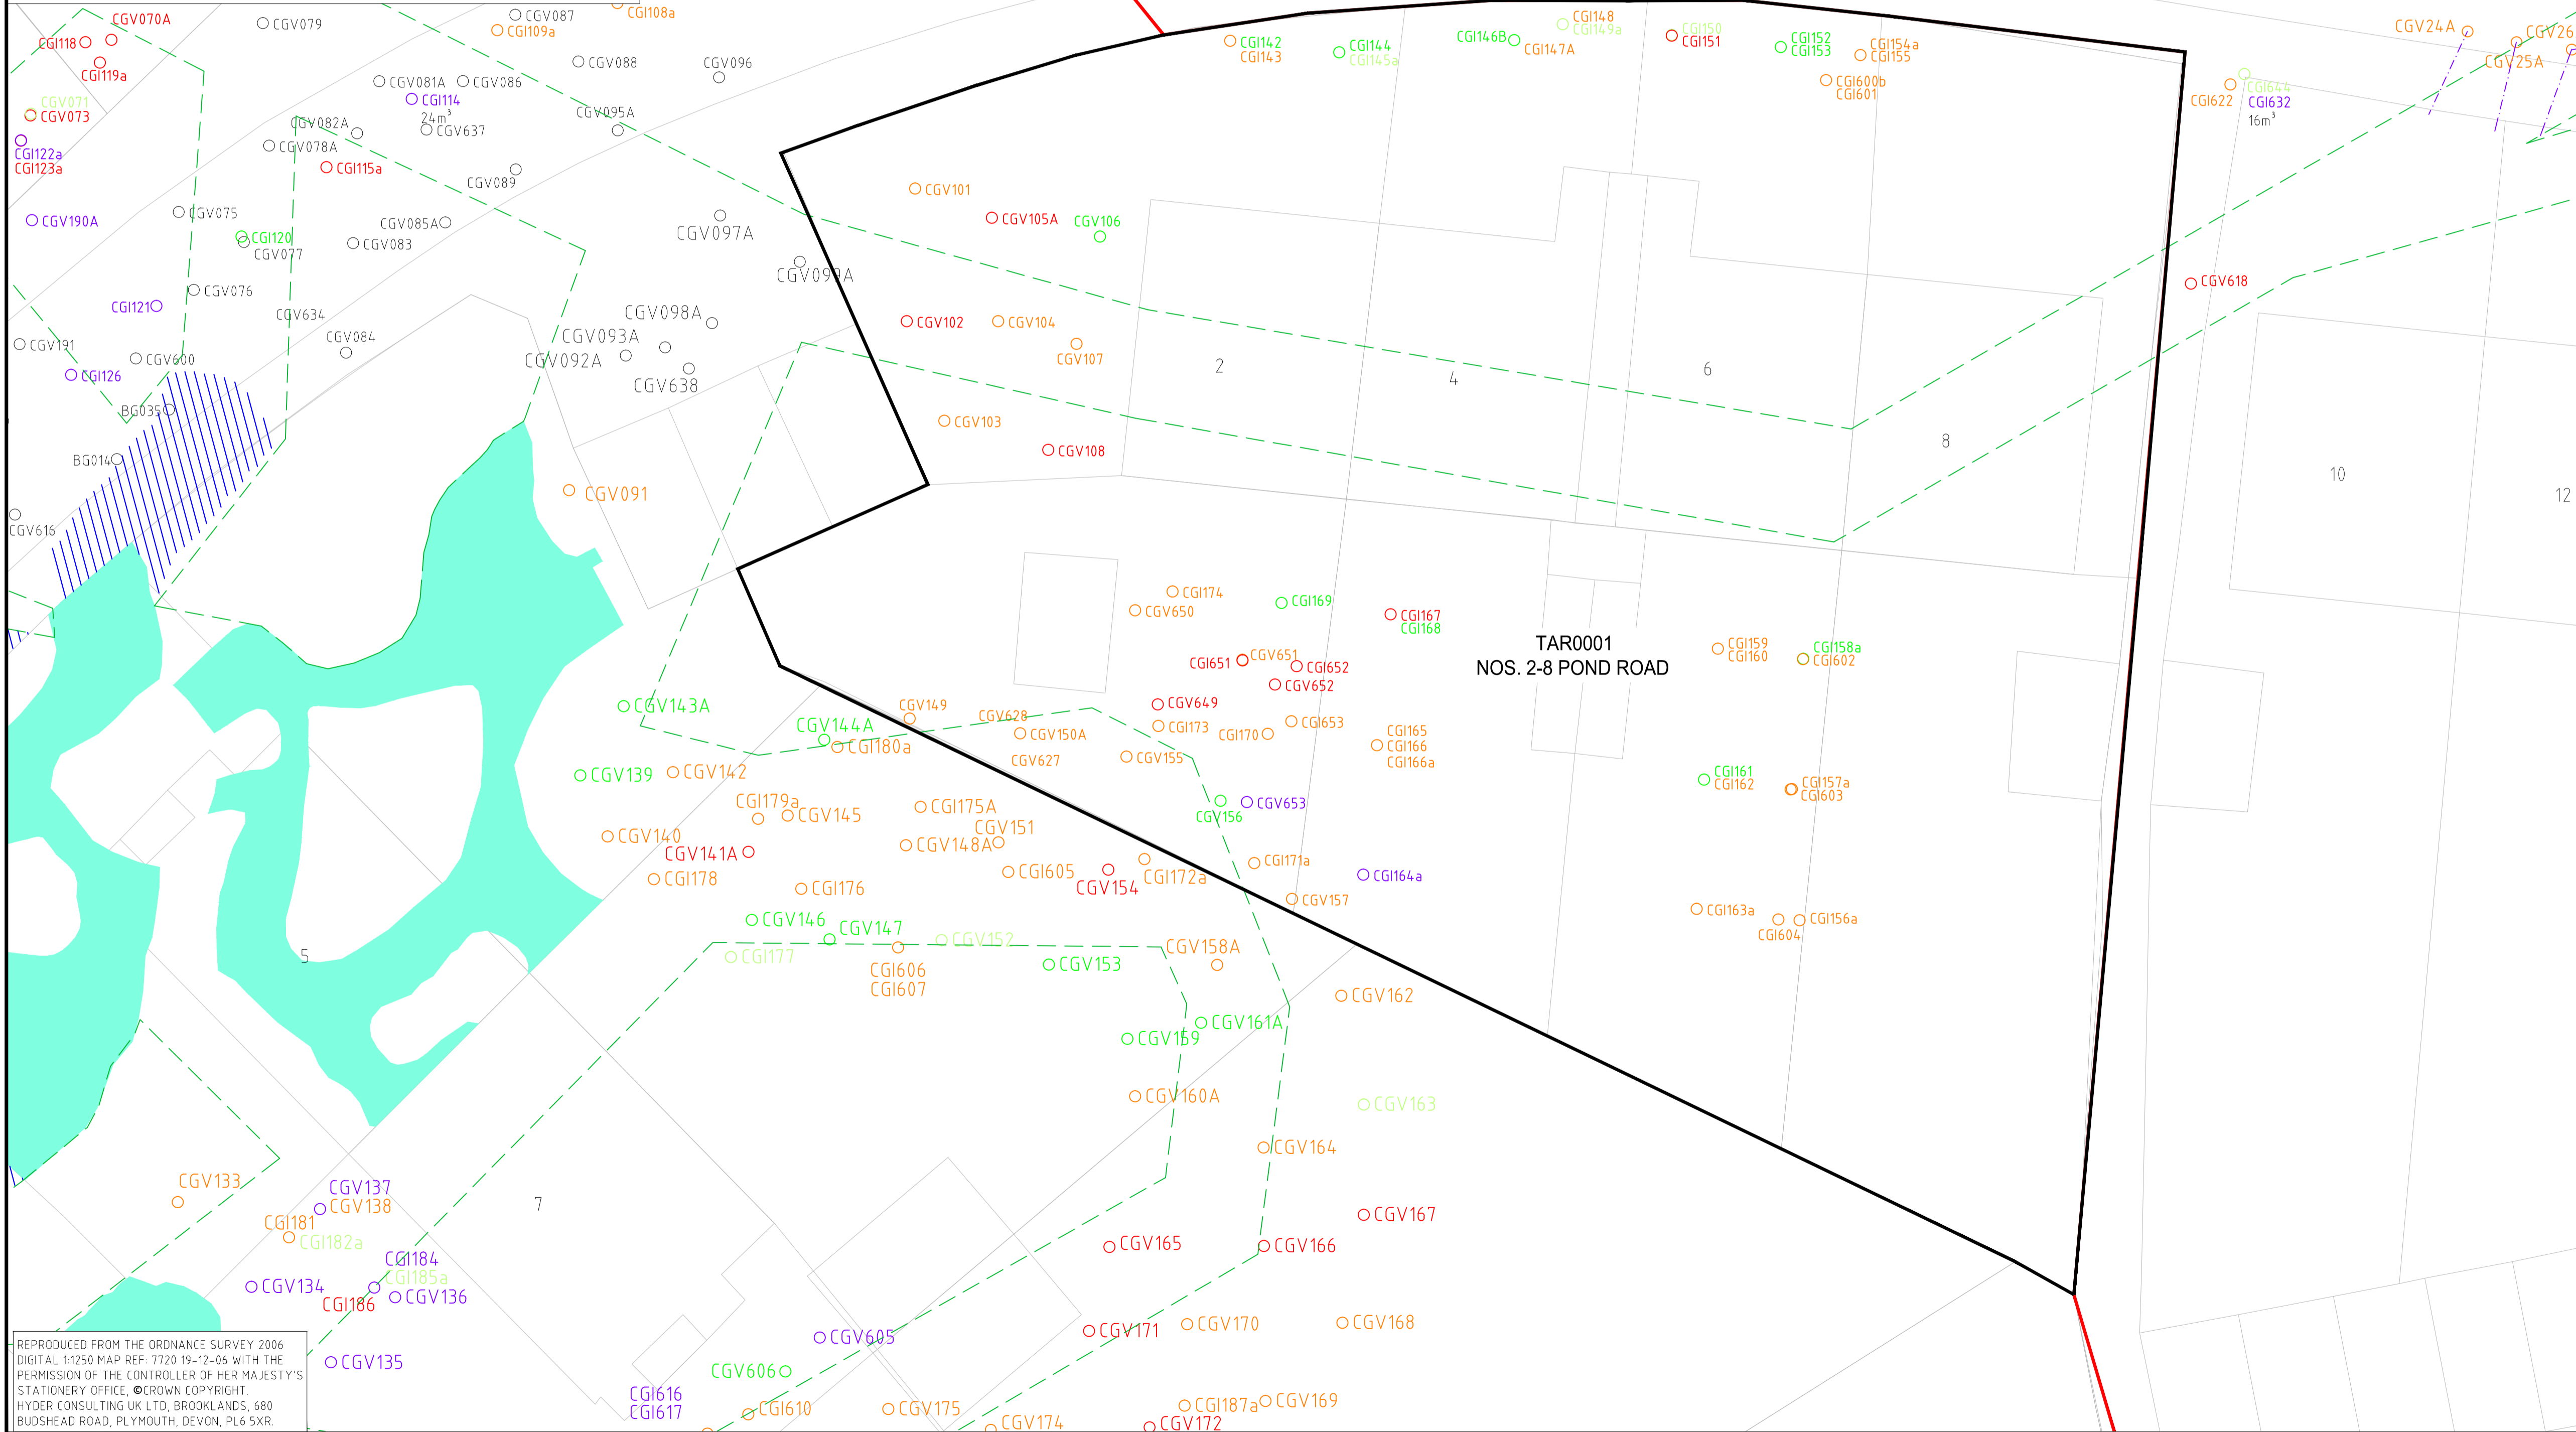
Drawing TA01-01 – Treatment Area Plan for TAR0001 with Grout Holes

The grout volumes at 2, 4, 6 & 8 Pond Road did not generally indicate open mines but, in some locations, are in excess of what might be expected from natural ground. Grout volumes across the treatment area generally ranged between a minimum of 0.58m³ and an average around 5.0m³ with occasional grout volumes in excess of 10m³. Additional grout treatment was undertaken at specific locations across the treatment area where higher than expected grout volumes were encountered or validation probes indicated weak ground not previously identified. Specific observations for each property are set out in the subsequent sections.

Grouting at No. 2 Pond Road was designed to treat a possible mine passage trending east-west beneath the property. In review of the Phase 1 ground investigation dynamic probe data, an anticipated grout volume of between 0.5m³ and 5.0m³ was expected in the region of the possible mine passage. Grout volumes of between 0.577m³ and 9.711m³ were recorded during a first phase of treatment works at No. 2. CGV105 recorded a grout volume of 5.5m³ between depths of 21.0m and 23.0m. A review of adjacent validation probe VP043 did not indicate the presence of mine workings at this depth or at any level in the probe. Therefore, the high grout volume recorded at this location is considered to represent a locally weak band or a heavier fractured zone of chalk. With the exception of VP146, validation probe results from the initial phase of validation/investigation testing undertaken during March and April 2013 confirmed a general improvement of the relative density of the ground following treatment. Results from validation probe VP146 showed low blow counts and a potential for mine workings between depths of 12.2m and 13.2m below ground level (bgl). As a result, a second phase of investigative probes were undertaken.

This second phase of investigative probes was carried in September 2013 with the objective of investigating the extent of potential mine workings in the vicinity of, and extending from VP146. A review of results indicated weak potentially mined ground in the rear garden of No. 2 Pond Road. As a result, a third phase of investigative probes was carried out in November 2013. Validation probes VP710 and VP711 recorded low blow counts between depths of 12.3 and 15.4m bgl and results of validation probing in adjoining areas (VP709, VP712 and VP664) indicated potential mined ground between depths of 11.2m and 15.3m bgl.

Consequently, a secondary phase of treatment involving both vertical and inclined compaction grouting was undertaken during December 2013 in the rear garden of No. 2. Recorded grout volumes ranging between 2.336m³ and 12.913m³ were comparable with the anticipated quantities as based on the identified vertical and lateral extents of mining related ground and there was a gradual reduction in volumes as grouting work progressed.

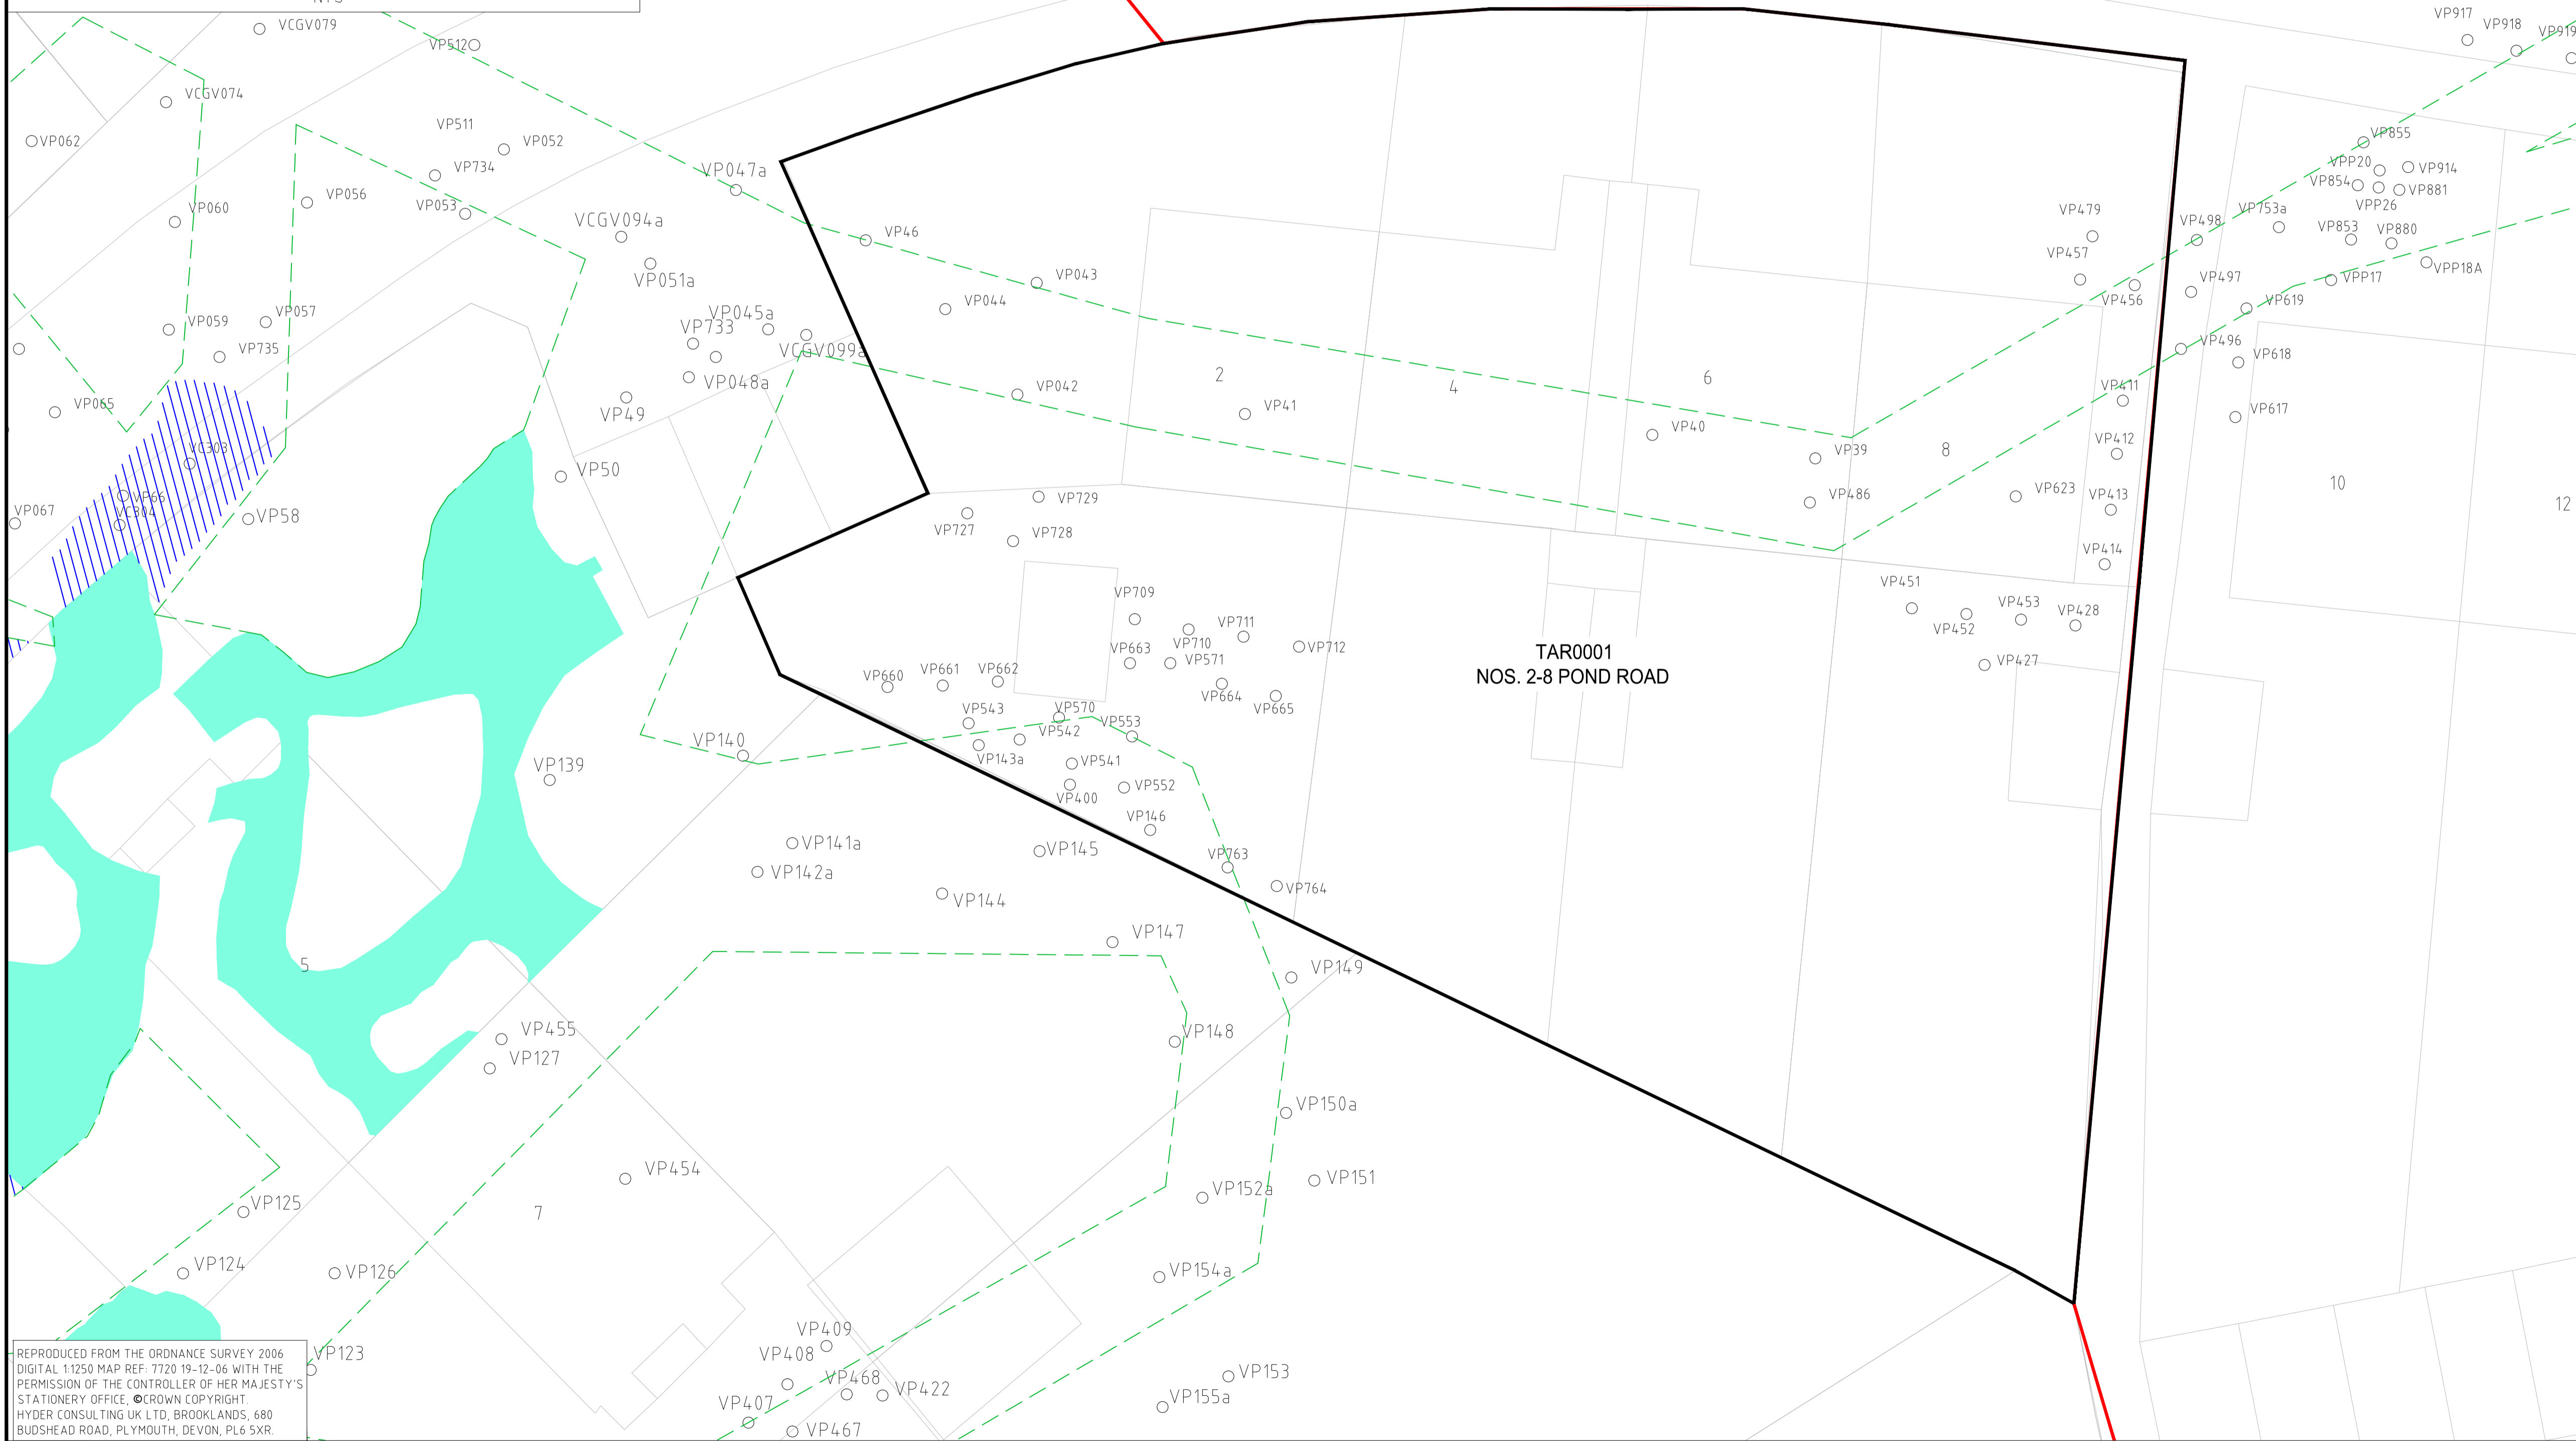
Drawing TA01-02 – Treatment Area Plan for TAR0001 with Validation Probes

Grouting of No. 4 Pond Road was designed to treat the possible mine galley extending from No. 2 Pond Road beneath the building. An interpretation of the expected mine layout for No. 4 Pond Road is shown on Drawing TA0001-02 presented in Appendix A.

A total grout volume of 37.0m³ was injected from ten inclined compaction grout holes directed beneath the dwelling during one single phase of treatment. Grout volumes ranging between 0.93m³ and a maximum volume of 14.5m³ recorded in CGI164 located in the rear garden. This was located in relatively close proximity to mining related ground identified in the rear garden of No. 2 and indicates a general improvement of the relative density of the ground following treatment works and the records show a gradual reduction in grout volumes as treatment progressed.

Three validation probes undertaken within the building (VP039, VP040 and VP486) all indicated a general improvement in the relative density of the ground in this area .

Validation probing was undertaken within the garden of No. 8 Pond Road to investigate the western extent of the mine. This phase of validation probes could not penetrate deeper than between 15.0m and 21.6m and did not find weak ground indicative of collapsed mine workings as found elsewhere in the gardens of adjacent properties.
